INSPECTION REPORT FOR CLIENT

RESIDENTIAL INSPECTION ADDRESS

1234 YOUR STREET
YOUR CITY, TEXAS 77---

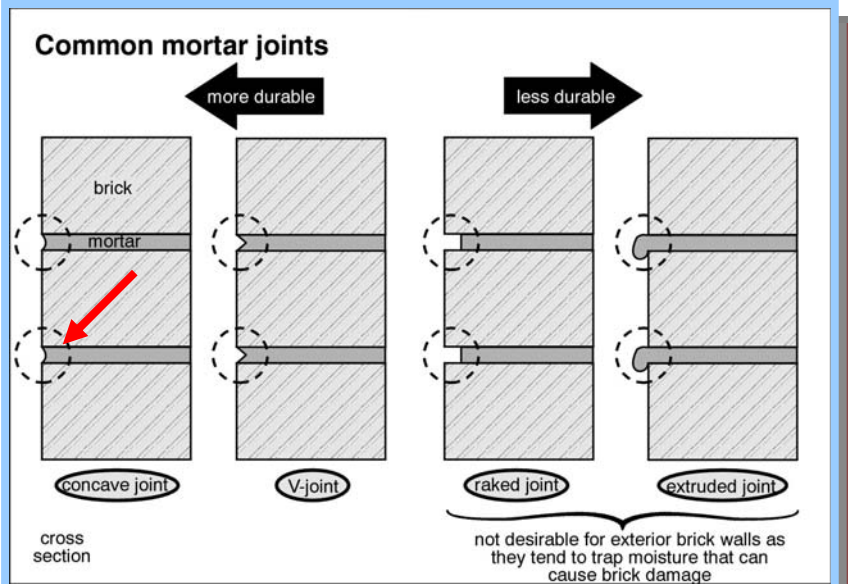
BRICK VENEER-WITH SOME EXPANSION JOINTS

Expansion joints are used to separate brick masonry into segments to prevent cracking due to changes in wall temperature, moisture expansion, elastic deformation, creep and other foundation or structural movement. The joints are formed of highly elastic materials placed in a continuous, unobstructed opening through the single thickness brick wall or section. Although the primary purpose of expansion joints is to accommodate movement, the joint must also resist water penetration and air infiltration. Mortar should not bridge the expansion joint and thereby restrict movement of the joint. **The joints located at the side walls appeared to be in satisfactory condition.**

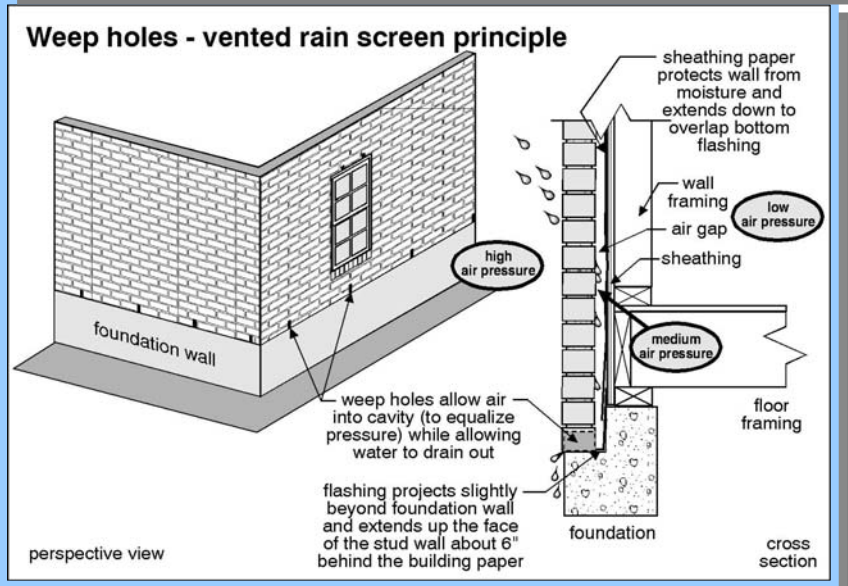
WEEP HOLES

Weep holes are openings placed in mortar joints at the level of any flashing such as window lintels and at the 1st course of bricks in order to permit the escape of moisture. The lack of weep holes above metal window lintels may contribute to lintel corrosion and the lack of weep holes at the 1st course of bricks over the slab brick ledge may contribute to interior water penetration at floor level and wall stains. Mortar droppings behind the veneer wall may restrict air flow and water drainage. Any water penetration within the brick veneer wall becomes a conducive condition for wood destroying insects and interior damage. **Lower level exterior veneer wall weep holes were provided. The presence or condition of any flashing behind the weep holes is unknown to me.**

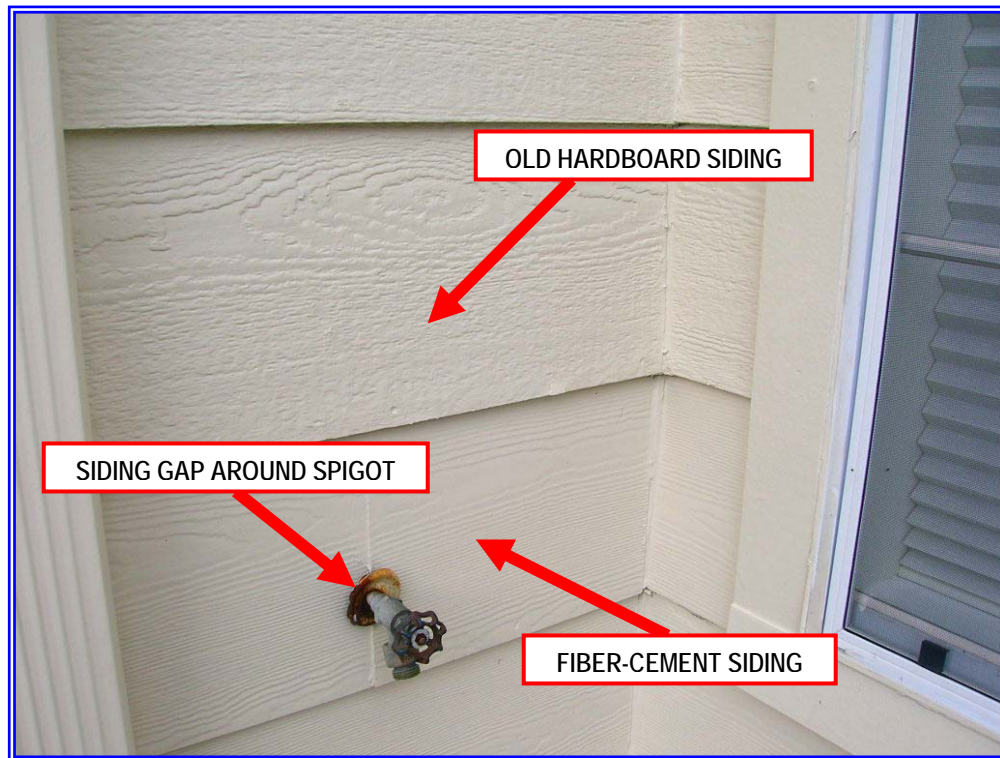
HARDBOARD SIDING AT UPPER LEVELS – FIBER-CEMENT SIDING AT LOWER LEVELS

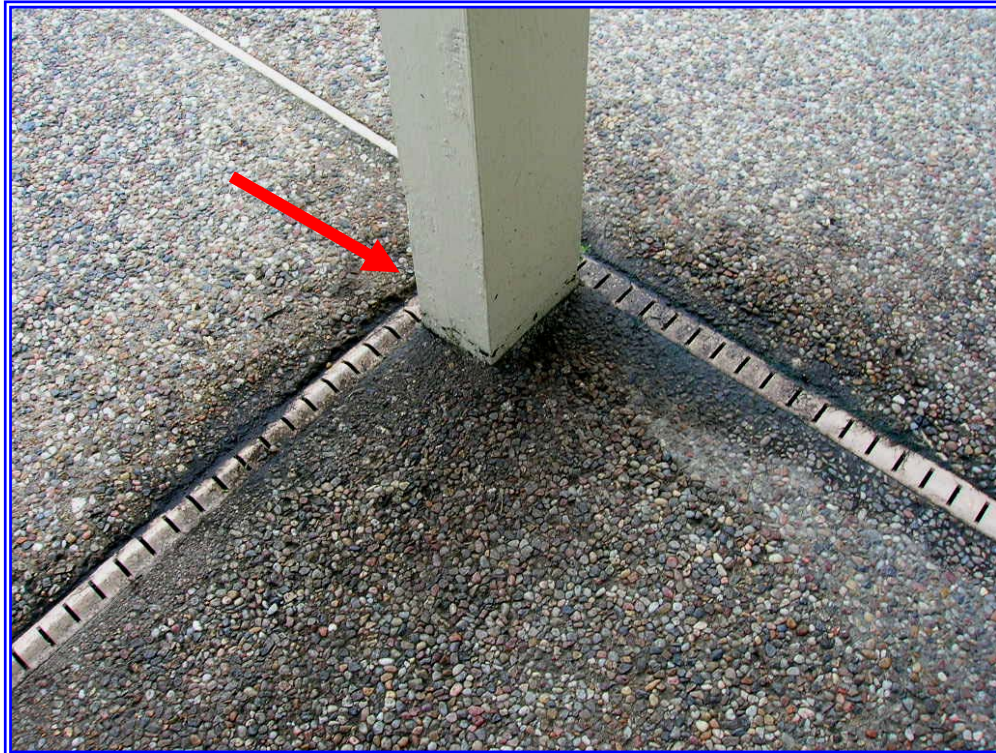
WOOD POST MAKING CONTACT WITH PATIO CONCRETE

1. The rear patio exterior wood post was in direct contact with exterior concrete. To minimize lower level deterioration from the elements, wooden posts should be separated from the concrete by approved spacers or mounting devices.
2. Seal gap along the vertical siding trim at the rear north corner.
3. Seal hose spigots where they pass through the exterior walls.

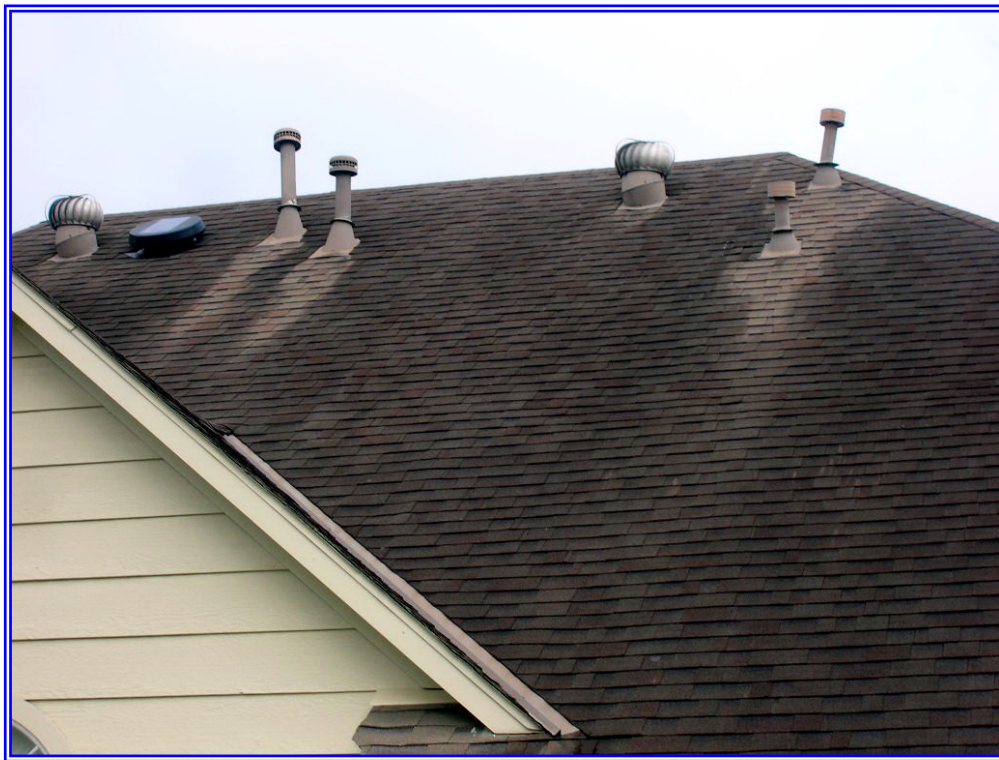
DARK STAINS ON THE AGING SHINGLES

I observed stains and dark discoloration on various shingles. Various algal, fungal, lichenous and cyanobacterial biological growths generally cause these conditions. The result is an unsightly appearance that may be mistaken as soot, dirt, moss, or tree drippings. The species of algae usually observed in this area is *Gloeocapsa*, which is transferred through the air and deposited on the roof covering where it continues to grow. The "stain resistant" shingles available from some manufacturers offer 5+ years of resistance and then capitulate to this growth. Under unusually excessive growth conditions, the UV radiation absorbed by this dark growth can have a negative effect on the shingles and thereby reduce life expectancy.

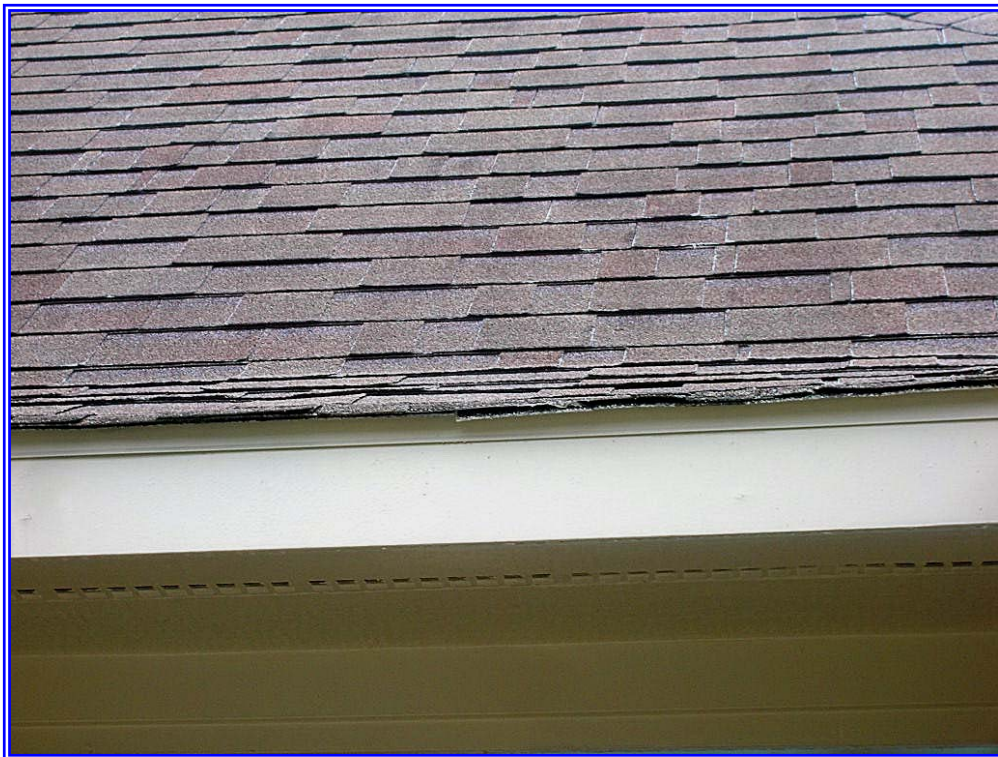
EXPOSED FIBERGLASS MATT AROUND THE EDGE OF THE SHINGLES

1. The shingles have exposed fiberglass matt around some edges. This denotes the end of useful service life. The roof shingles should be replaced. Any new installation should follow current approved industry standards for materials and installation techniques. Consult with your insurance agent to determine structure insurability with current roof covering condition.

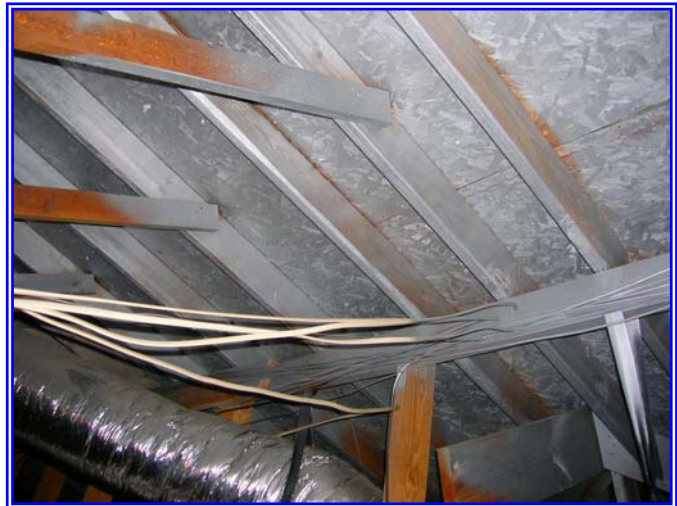
OSB ROOF DECKING WITH RADIANT BARRIER PAINT

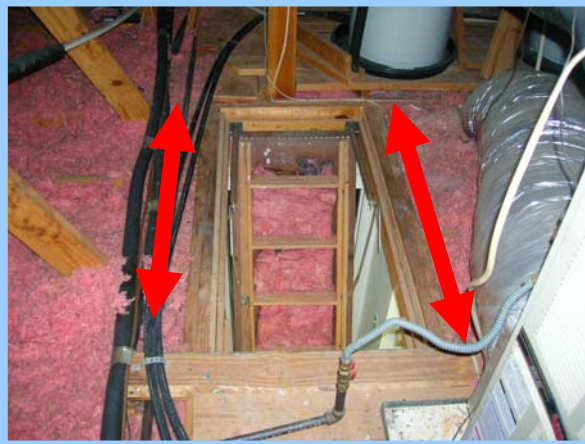
INADEQUATE DECKING ALONG SIDES OF STAIRWAY

1. Inadequate attic floor decking along the sides of the stairway opening to safely enter and leave the attic space. Unfortunately, there are too many pipes on the attic floor along the foot traffic areas. The traffic areas should be unobstructed.
2. Missing fasteners at the attic stairway spring and corner brackets. Use 16d nails. Gypsum board screws are not to be used on the attic stairway.
3. Remove the insulation batts on the attic stairway. Trip hazard.

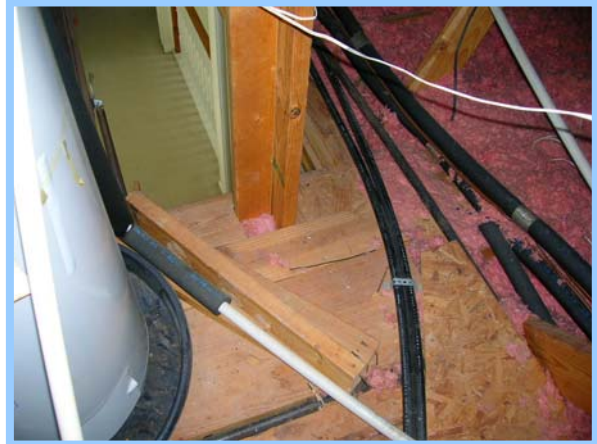
FLOOR PIPING RESTRICTS ACCESS TO WATER HEATER

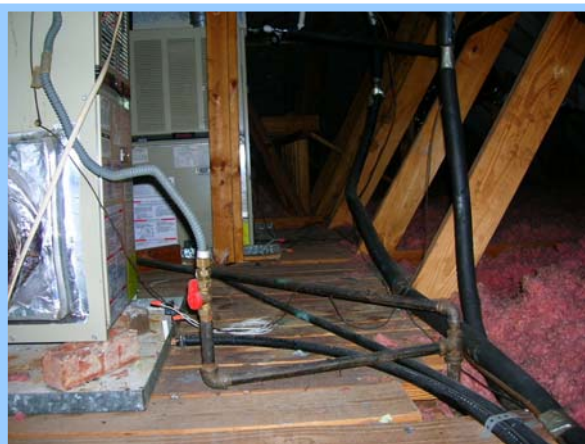
PIPING ON ATTIC FLOOR RESTRICTS ACCESS TO VARIOUS MECHANICAL EQUIPMENT

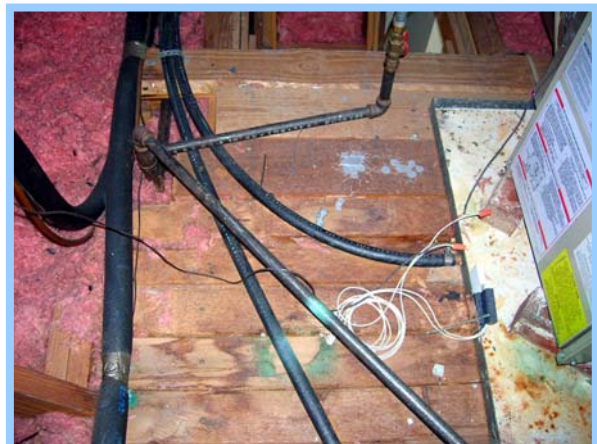
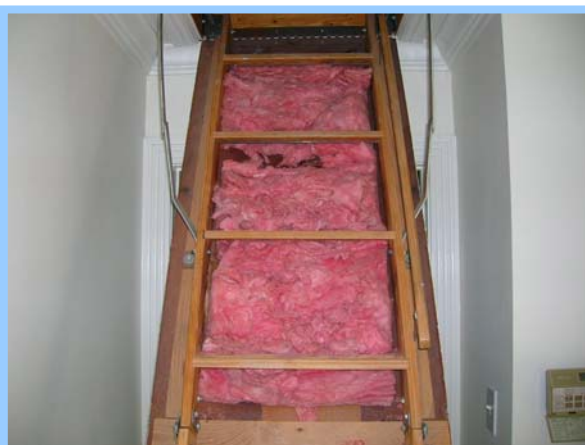
REMOVE INSULATION BATTS ON STAIRWAY

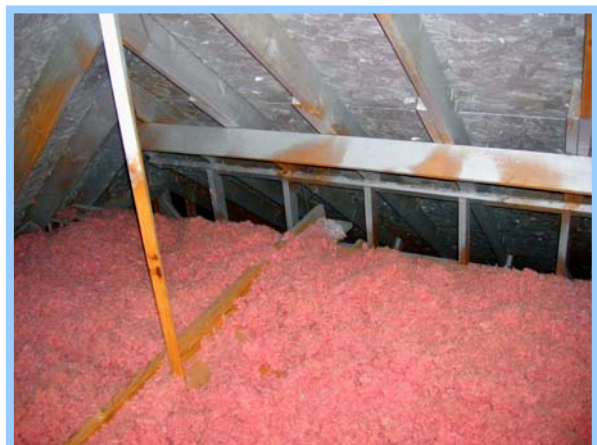
LOOSE FILL FIBERGLASS INSULATION

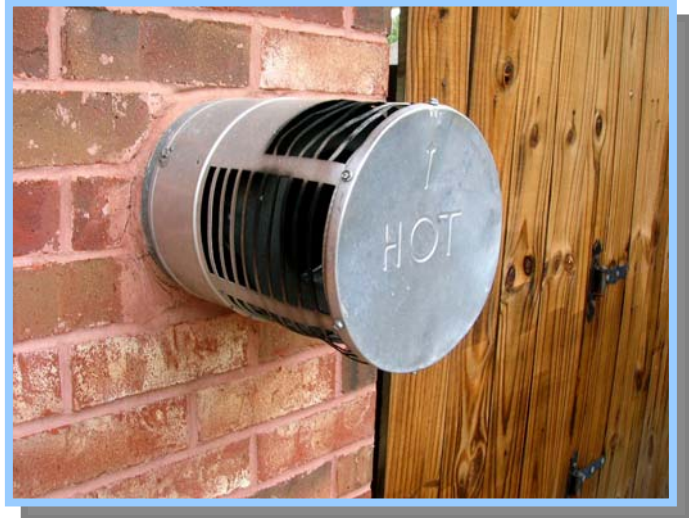
DO NOT COVER THE EXTERIOR VENT

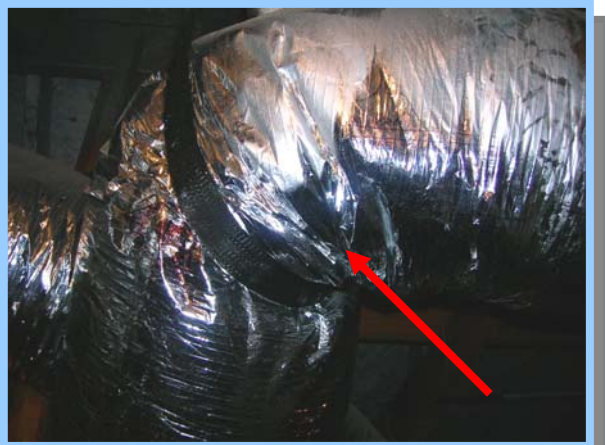
SHARP DUCT BENDS REDUCE AIR FLOW

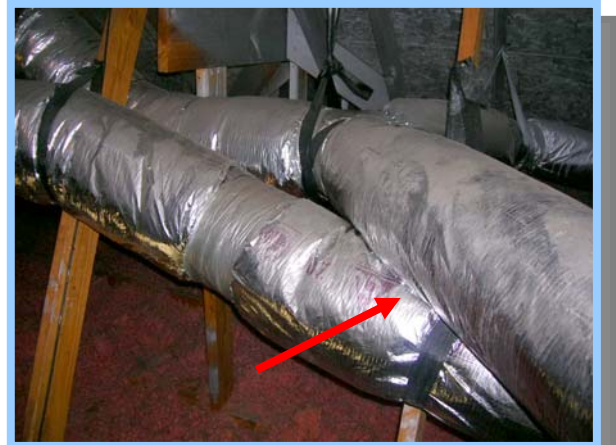
DUCTS SHOULD NOT TOUCH OTHER DUCTS

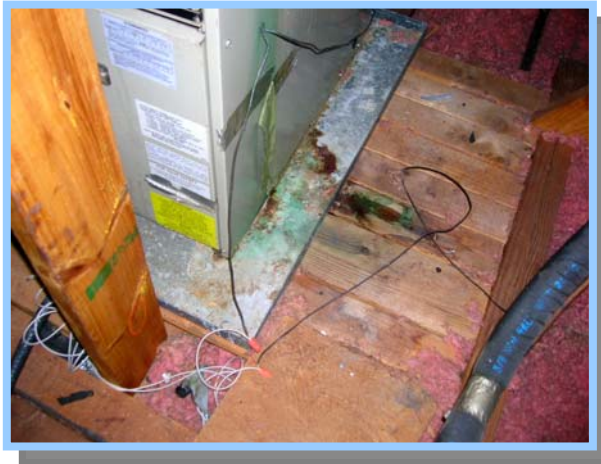
DIRTY DRAIN PAN UNDER 1ST FLOOR UNIT

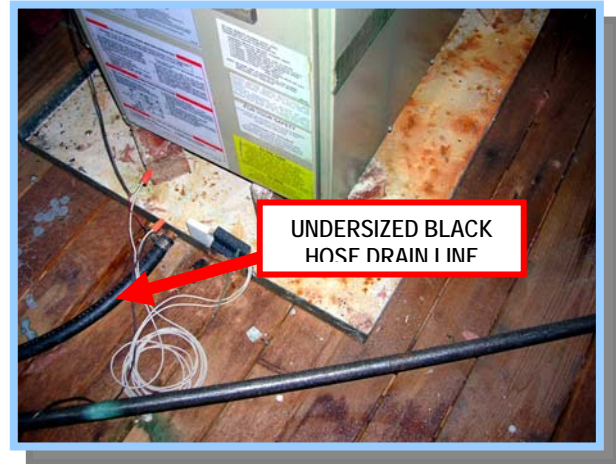
RUSTING DRAIN PAN UNDER 2ND FLOOR UNIT

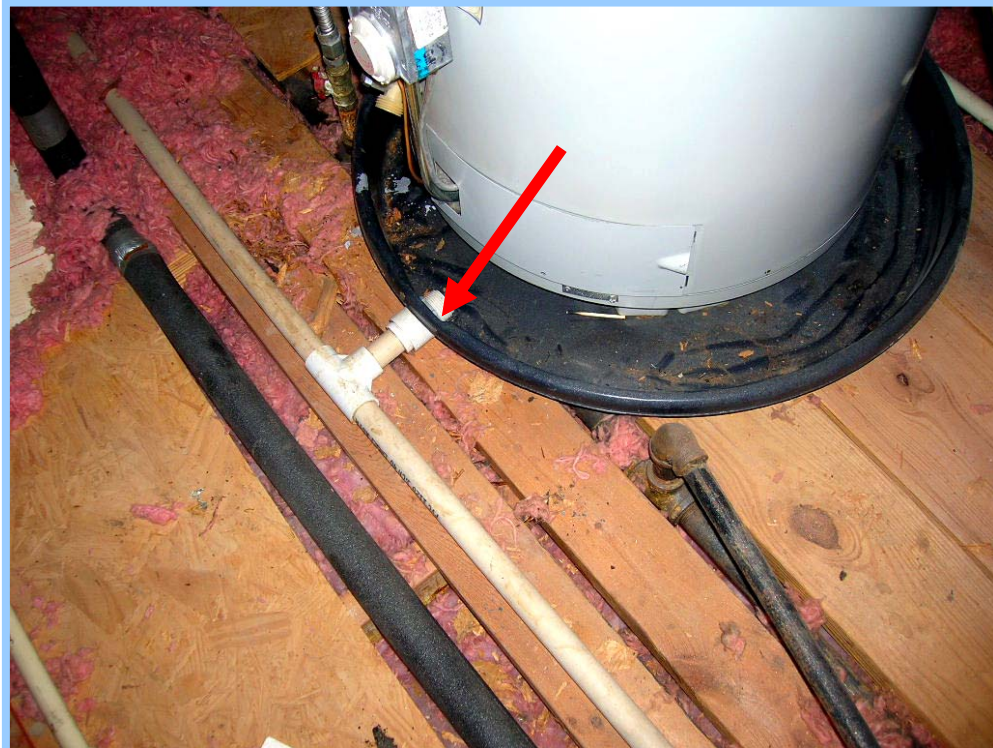
PLASTIC PANS UNDER THE HEATERS ARE CONNECTED TO A COMMON DRAIN LINE

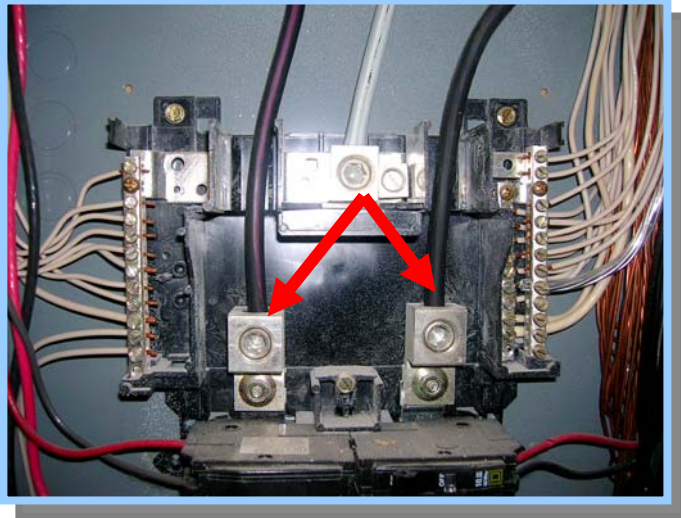
NO ANTI-OXIDANT PASTE AT
SUBPANEL ALUMINUM CONNECTIONS

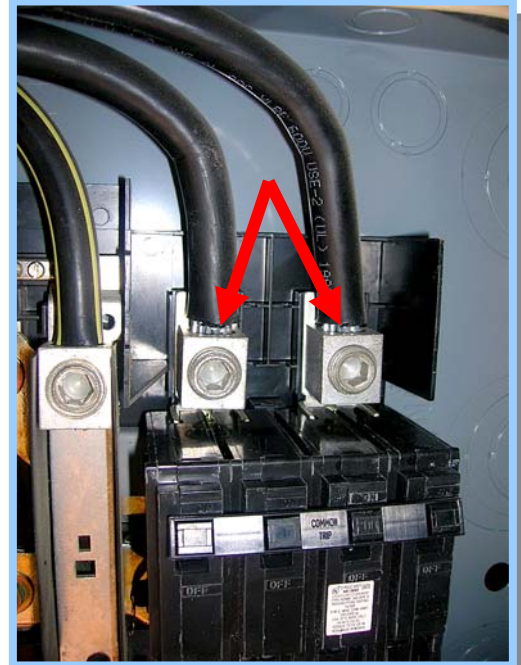
NO ANTI-OXIDANT PASTE AT
MAIN PANEL ALUMINUM CONNECTIONS

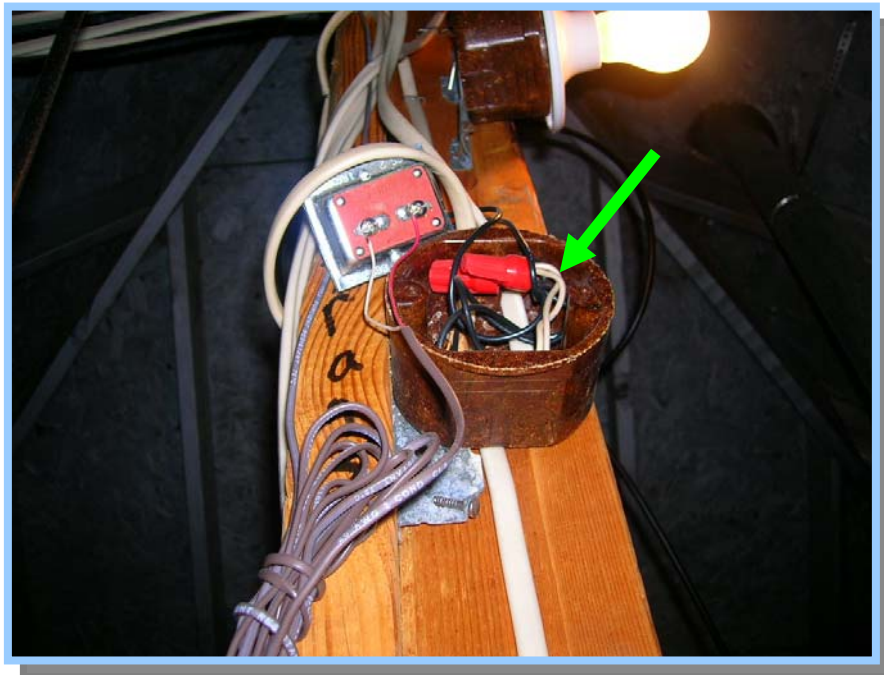
EXPOSED WIRE CONNECTIONS IN THE ATTIC SPACE

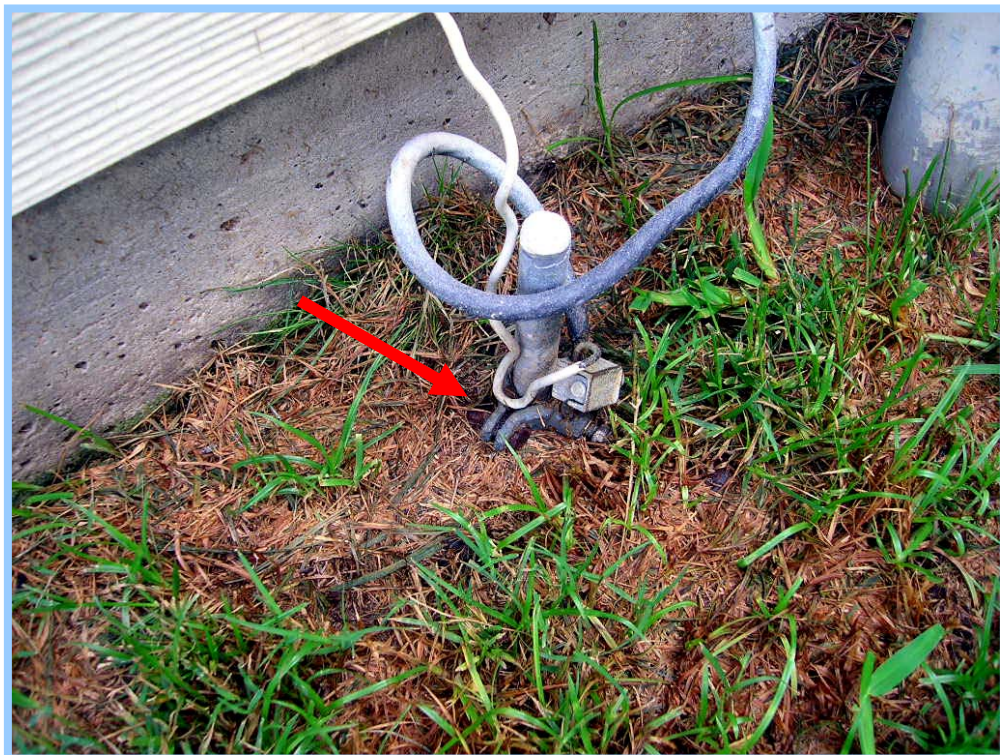
WRONG TYPE CLAMP AT EARTH GROUND ROD
