INSPECTION REPORT FOR CLIENT

RESIDENTIAL INSPECTION ADDRESS

1234 YOUR STREET
YOUR CITY, TEXAS 77---

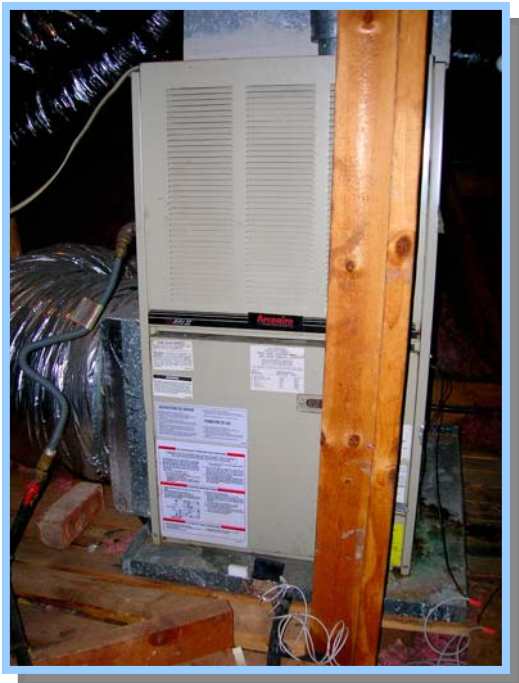
1ST FLOOR GAS FURNACE

DUCTS SHOULD NOT TOUCH OTHER DUCTS

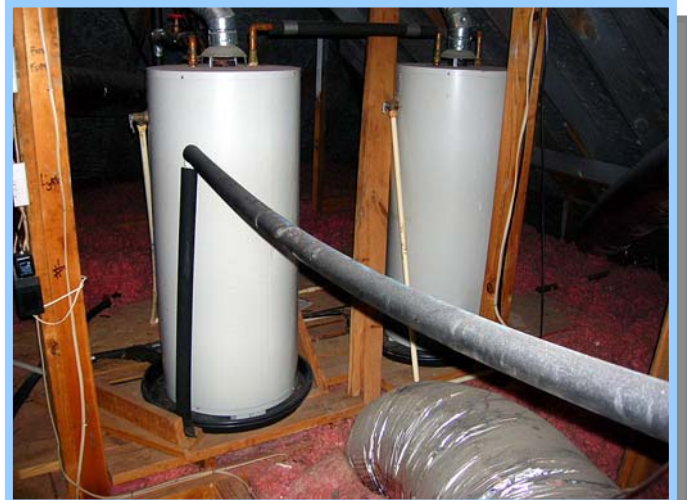
The manufacturer of the temperature/pressure relief valves recommends that any valves over 3 years old, based on the dating codes, should be removed by a qualified and/or licensed specialist for inspection or replacement. Any valve with an excessive accumulation of mineral and corrosion deposits should be replaced. **No visible corrosion of the relief valves was observed. These valves were dated 1994.**
